CALSPAN ON-SITE AIR BAG DEPLOYMENT INVESTIGATION

CALSPAN CASE NO. 96-02

VEHICLE #1 - 1995 ISUZU TROOPER (AIR BAG EQUIPPED)

VEHICLE #2 - 1986 BMW 325 ES

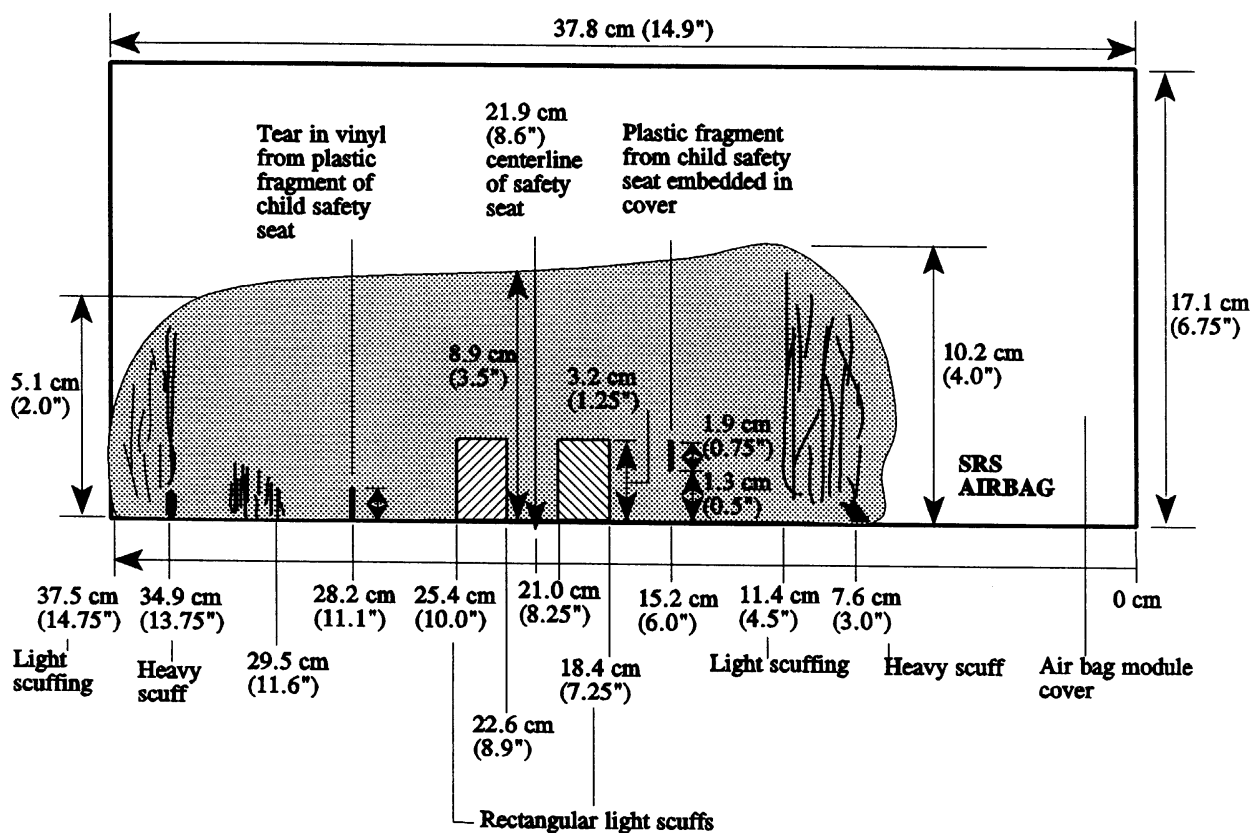
Contact Evidence On Surface Of Passenger Side Air Bag Cover

The passenger side air bag module cover sustained damage resulting from contact with the upper rear surface of the child safety seat. The perimeter of the contact pattern resembled the outline of the child safety seat which measured 10.2 cm (4.0") vertically from the cover's horizontal tear seam along the right side of the pattern, 5.1 cm (2.0") vertically along the left side, and 29.9 cm (11.8") laterally (refer to photographs #55-#58 on pages A-28, A-29). There were vertically oriented striated scuff marks and embedded plastic tabs from the rear surface of the child safety seat in the air bag module cover (refer to the following illustration for detailed measurements).

Imprint of the upper rear surface of the child safety seat is noted by the outline shown in the above sketch. There were two punctures of the air bag module cover which correlated with the two plastic tabs located 4.4 cm (1.75") below the top of the child safety seat and 6.4 cm (2.5") from the centerline of the seat. The right edge of the safety seat was located 34.9 cm (13.75") from the right edge of the cover.

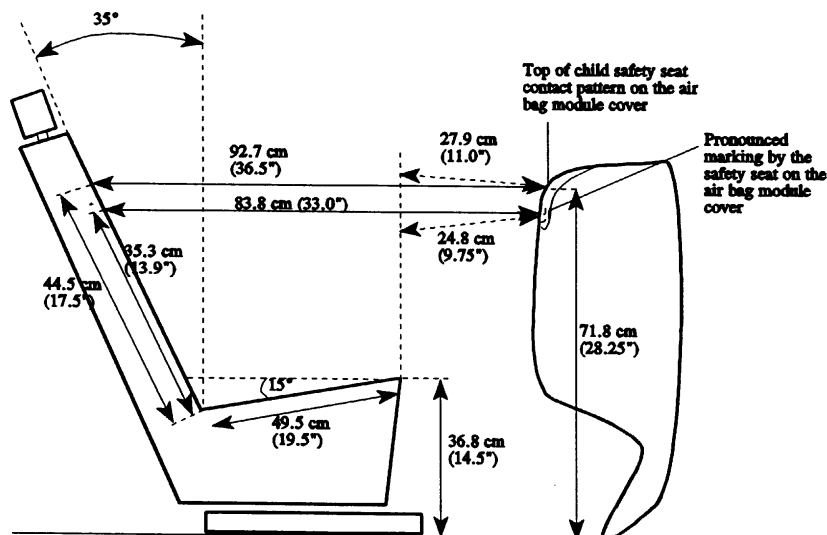
Right Front Passenger Seat Longitudinal Location With Respect To The Air Bag Module Cover

The seat was in the full rear adjusted position at the time of the inspection which appeared consistent with the position noted in on-scene police photographs. The seat track had an adjustment range of 18.0 cm (7.1"). When the seat was adjusted on the seat track to the specifications of the FV/MSS 208 test, the seat back rest measured a horizontal distance of 64.8 cm (25.5") to the air bag module cover and 82.6 cm (32.5") to the rear seat cushion.

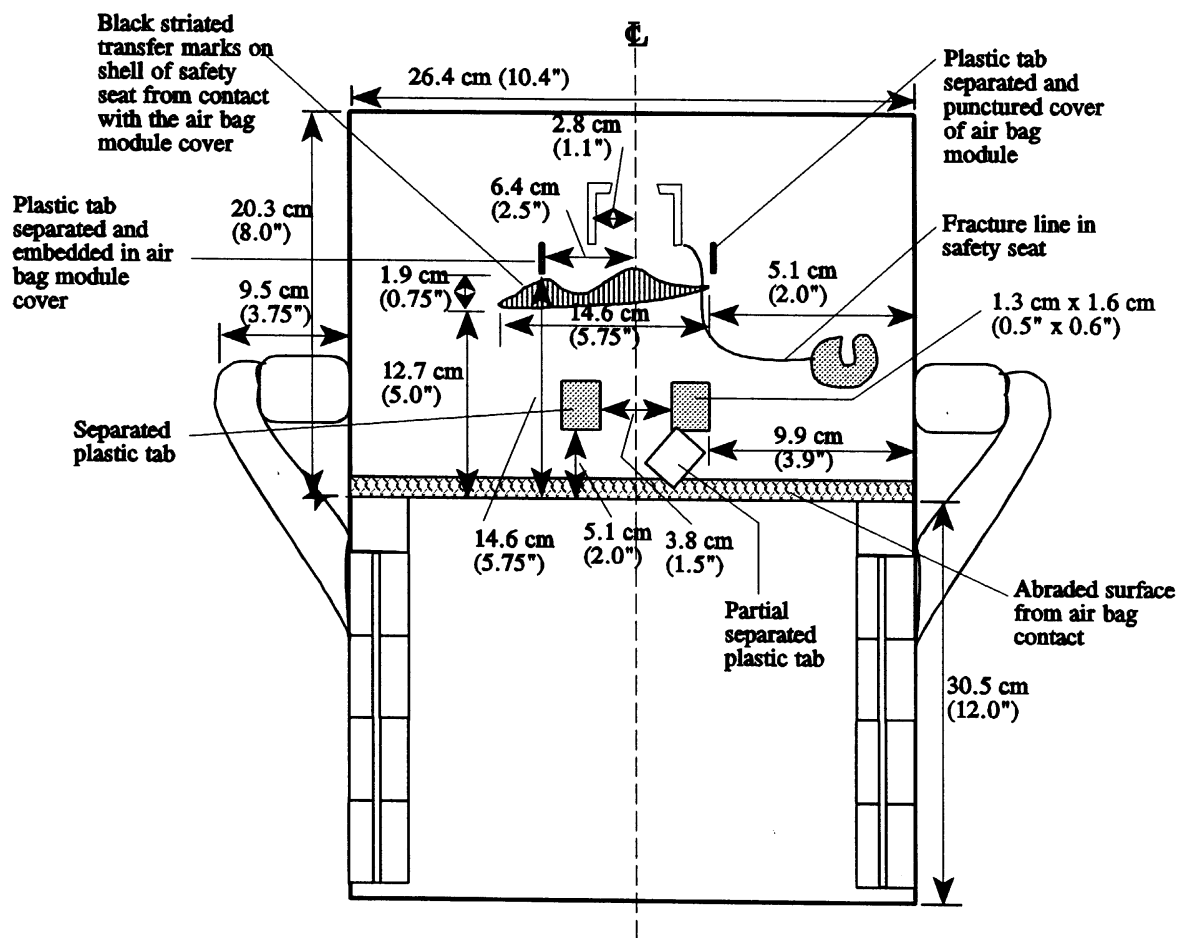
Contact Evidence On The Rear Surface of The Child Safety Seat

Contact evidence on the upper rear surface of the safety seat indicated the seat was very close to if not against the passenger air bag module cover at the time of the crash. Two plastic tabs molded into the rear surface of the plastic shell were broken off and embedded in the cover of the air bag module. This evidence in conjunction with black striated transfers from the module cover and a patterned abraded area from the air bag contact clearly aligned the position of the seat

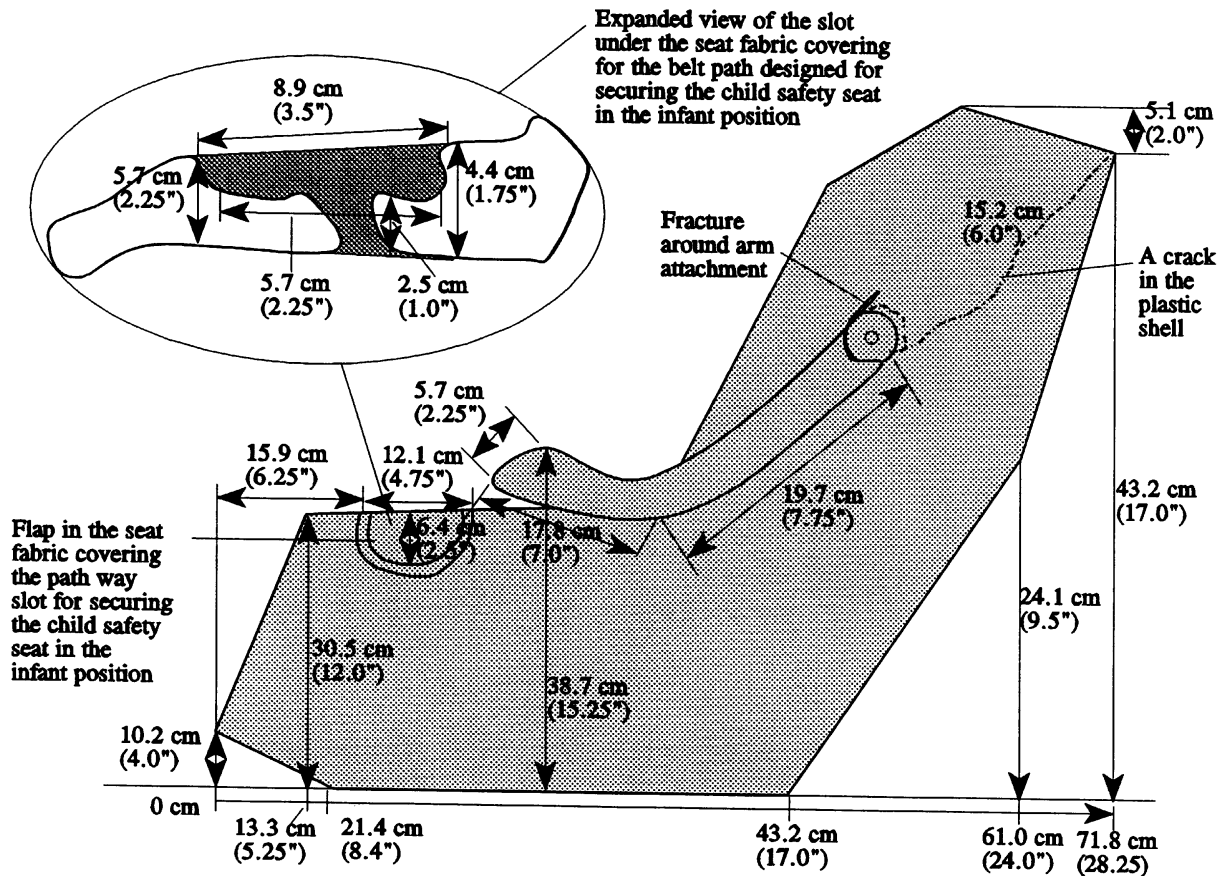
Profile of The Century 3500 STE Prestige

The fabric covering over the child safety seat was designed with flap pockets on the side surfaces which cover the rearward-facing latch brackets for the lap belt pathway. The flaps were observed in on-scene photographs to be tucked behind the seat covering. In order to correctly fasten the seat with the lap belt, these flaps must be pulled away from the seat to expose the latch brackets (refer to photographs #84-#86 on pages A-42, A-43). This ruled out the possibility that the child safety seat was secured properly using the designed belt pathway for the rearward-facing mode. The illustration on the following page provides detailed measurements of this area.

The plastic shell of the child safety seat was fractured in two places. The largest fracture site involved the left side surface of the seat in the area around the safety tray pivot arm. This fracture extended 15.2 cm (6.0") from the pivot arm to the top of the seat and may have resulted from contact with the right upper B-pillar. The second fracture site was located on the upper rear surface of the seat located between a manufactured opening in the seat (top right) and the instruction manual holding bracket. This was the result of contact by the air bag module cover and air bag during the deployment cycle (refer to photographs #89-#92 on pages A-45, A-46, A-47).

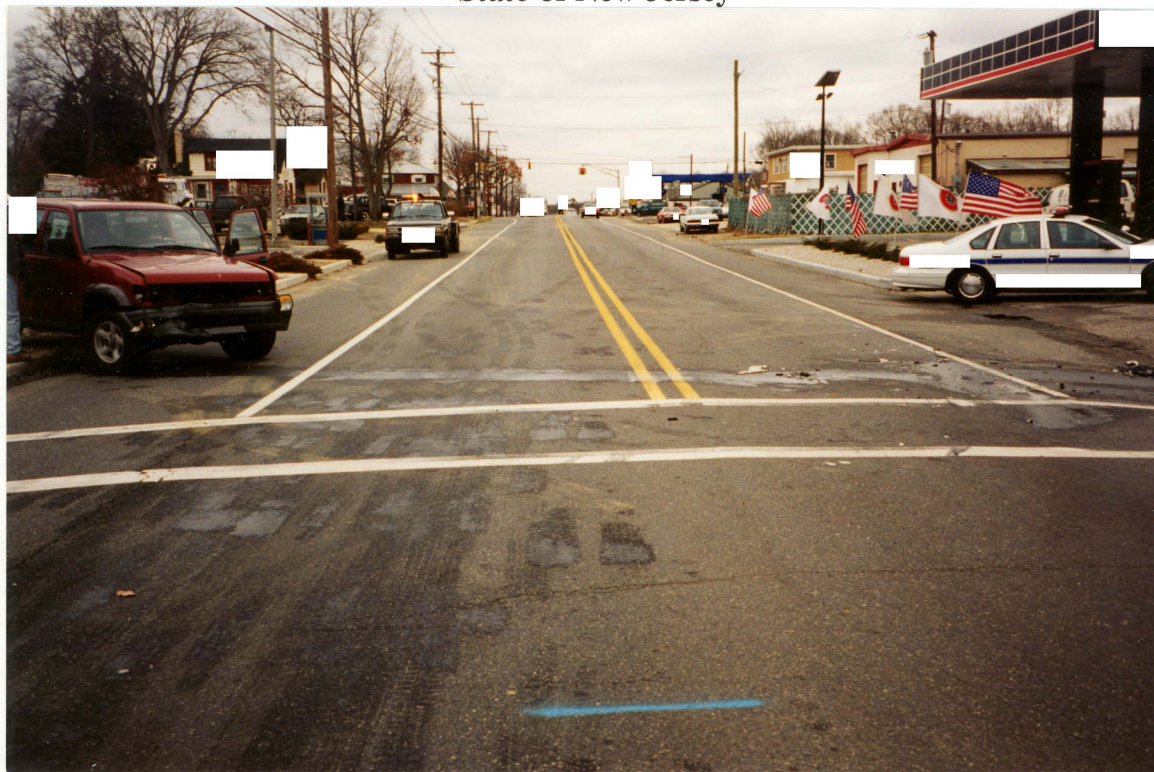
1. On-scene police photograph (looking east) showing the final rest position (FRP) of Vehicle #1 (1995 Izusu Trooper) and the point of impact (POI) with Vehicle #2 (1986 BMW 325 ES) noted by the fluid spill and debris near the right side of the photograph.

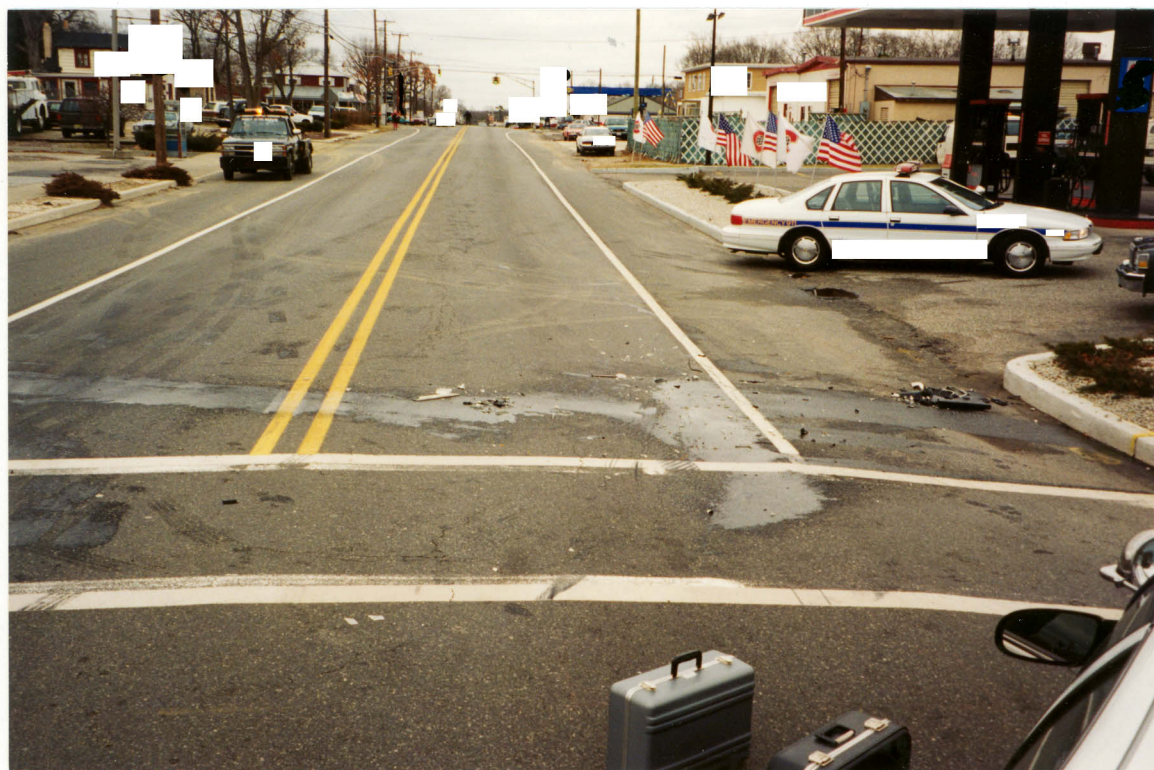
2. On-scene close-up view of the POI.

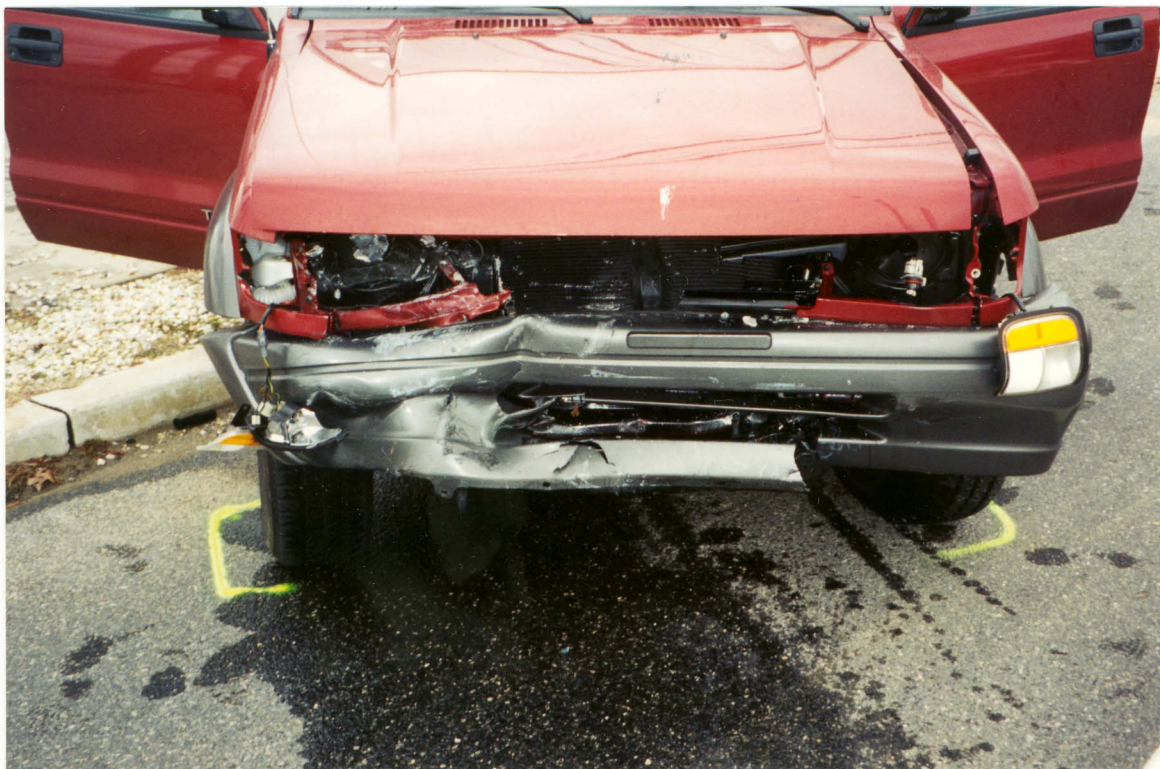
4. On-scene close-up view of impact damage to the front of Vehicle #1.

The frontal plane of the 1995 Isuzu Trooper struck the frontal plane of the 1986 BMW 325ES. Direct contact was noted across an area measuring 147.3 cm (58.0") which was located 69.9 cm (26.75") left of the vehicle centerline. Contact damage involved the front bumper, grille area, headlights, marker lights, directional signal lamps, the hood, and both fenders. The front bumper sustained a maximum rearward displacement of 38.6 cm (15.1") which was located 36.8 cm (14.5") right of the vehicle centerline. The maximum crush area resulted from contact with the left front bumper corner of Vehicle #2. The combined direct and induced damage length measured 161.3 cm (63.5") (refer to photographs #24 - #29 on pages A-12 through A-15). Crush values obtained along the bumper level are listed below:

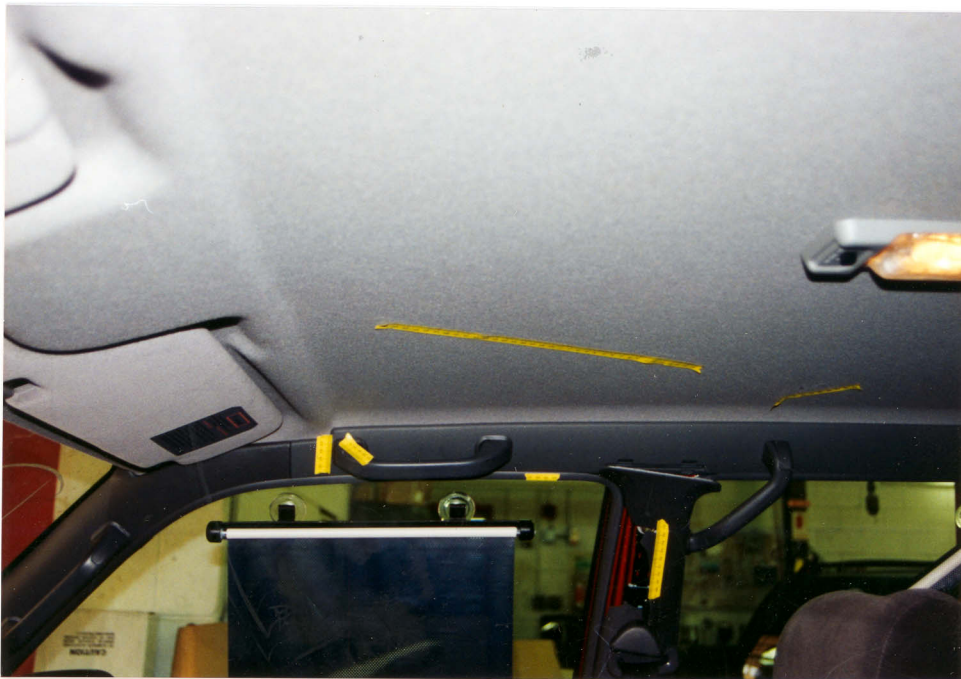
38. Closer view of the roof and right upper B-pillar highlighting a liner abrasion along the roof fabric and the fracture of the vinyl shroud over the pillar.

The vinyl covering over the right upper B-pillar was cracked and fragment from contact with the child safety seat. Green fabric fibers located on the leading edge of the fracture site were consistent with the color of the child safety seat fabric covering.

A 32.4 cm (12.75") linear gray color transfer was noted on the surface of the roof fabric. The transfer began 21.6 cm (8.5") right of the centerline and stopped 34.3 cm (13.5") right of the centerline. This was attributed to contact by the child safety seat, even though there was no correlated damage noted on the safety seat.

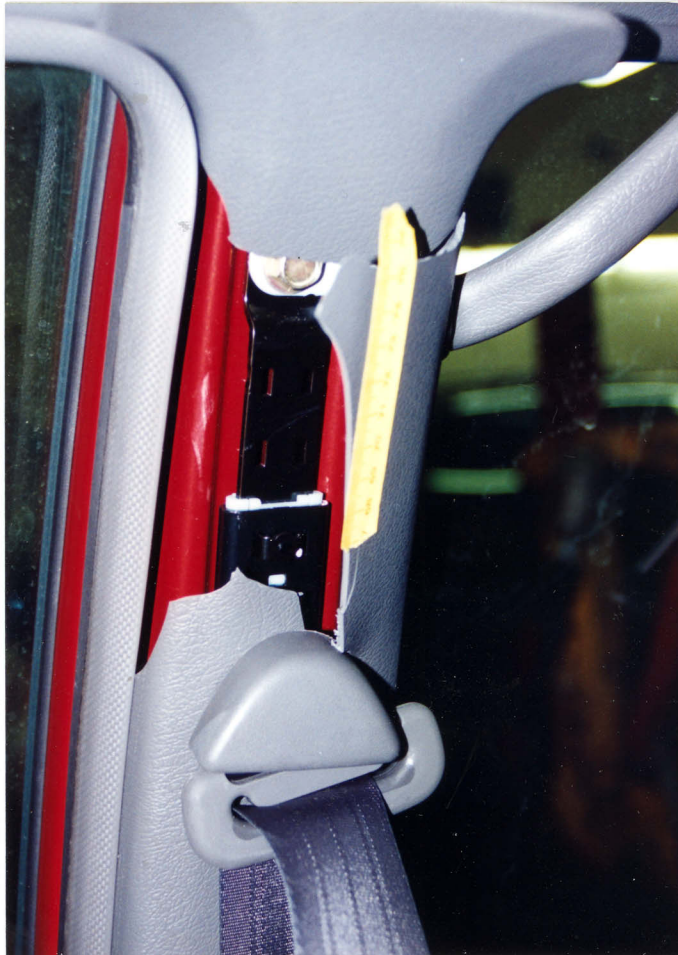
39. Close-up view of the fractured vinyl shroud over the right upper B-pillar.

Contact on the upper B-pillar resulted in the fragmentation of the plastic covering in an area measuring 17.8 cm (7.0") located 7.0 cm (2.75") below the right roof rail. Green fabric fibers consistent with the color of the safety seat covering was noted along the leading edge of the fracture site. The safety seat fabric along the left top surface on the in-board surface of the left head wing sustained a "L" shaped tear measuring 2.2 cm (0.9") vertically and 0.6 cm (0.25") laterally. This was consistent with the contact pattern on the upper B-pillar (refer to photograph #39 on page A-20).

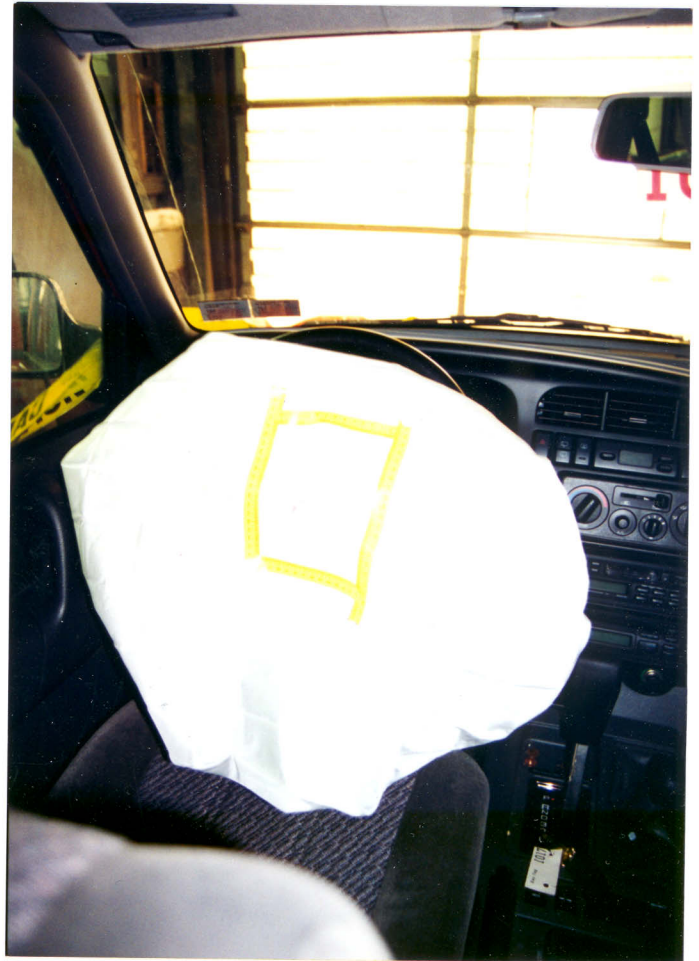
48. Close-up view of lipstick and mascara on the surface of the driver side air bag.

A 10.8 cm (4.25") tan (peach color) mascara transfer mark was noted on the surface of the air bag. It was located in the center of the air bag and extended 15.2 cm (6.0") vertically (refer to photographs #47, #48 on page A-24). This mark was the result of contact by the driver's facial area. With this transfer were two parallel red lipstick transfers which measured 8.3 cm (3.5") in length. The pattern of the marks indicated the steering was rotated approximately 90° counterclockwise at impact.

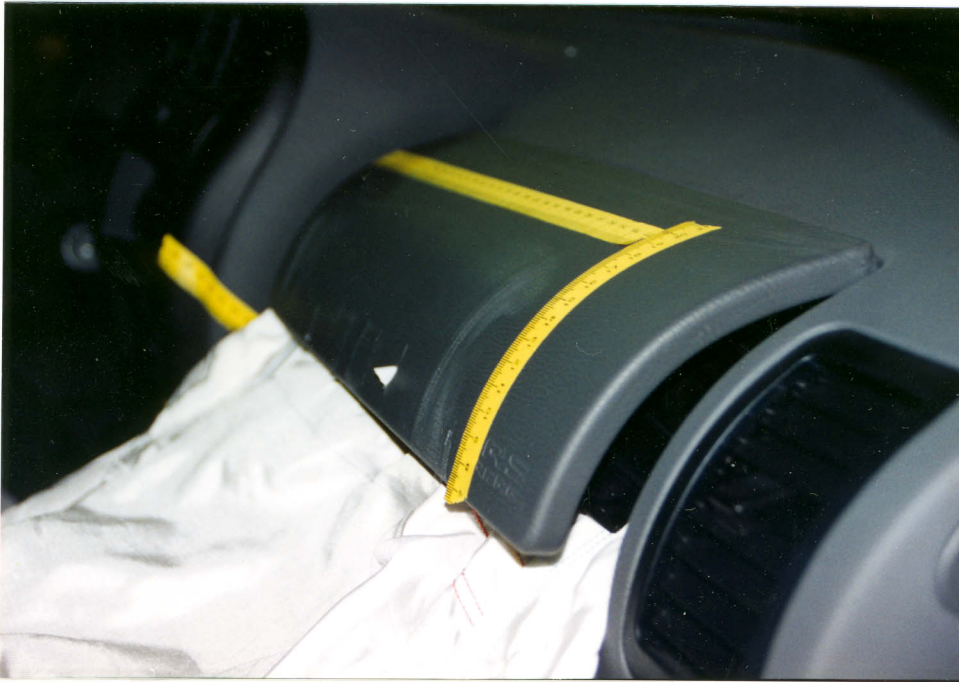
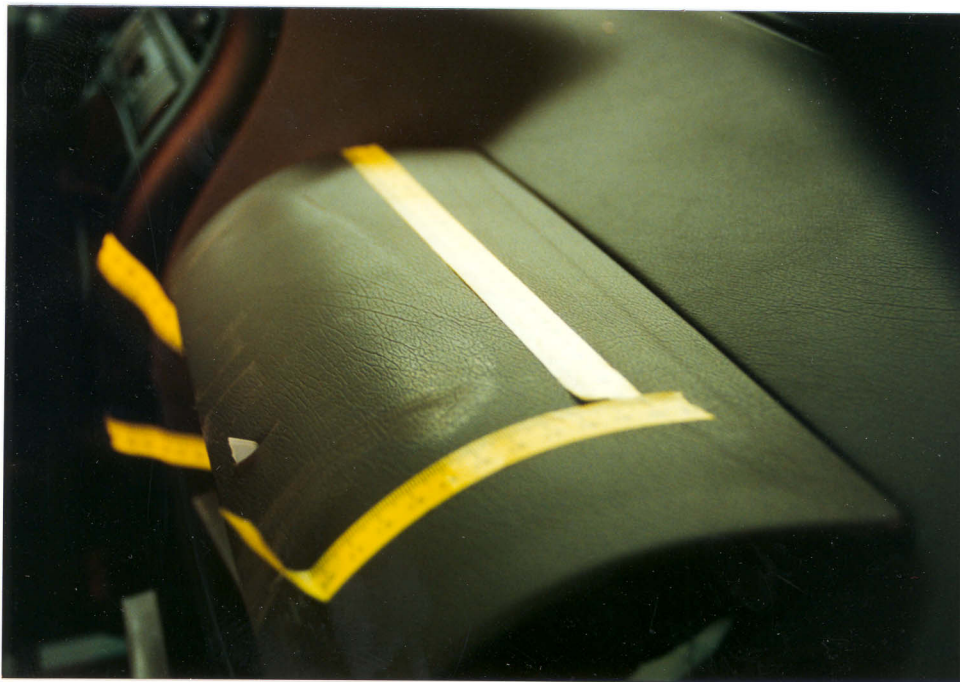
57, 58. Lateral views of the passenger side air bag module cover looking from right to left showing contact evidence associated with the rear surface of the infant child safety seat. The small light colored vinyl fragment noted near the bottom edge of the cover was part of the safety seat that was embedded in the surface of the cover. The outline of the child safety seat is more prominent in photograph #58.

Damage to the interior was associated with occupant contacts. The passenger side air bag module cover exhibited a contact pattern which correlated with the upper rear surface of the child safety seat. The perimeter of the contact pattern measured 10.2 cm (4.0") vertically from the cover's horizontal tear seam along the right side of the pattern, 5.1 cm (2.0") vertically along the left side, and 29.9 cm (11.8") laterally. There were vertically oriented striated scuff marks and embedded plastic tabs from the rear surface of the child safety seat in the air bag module cover.

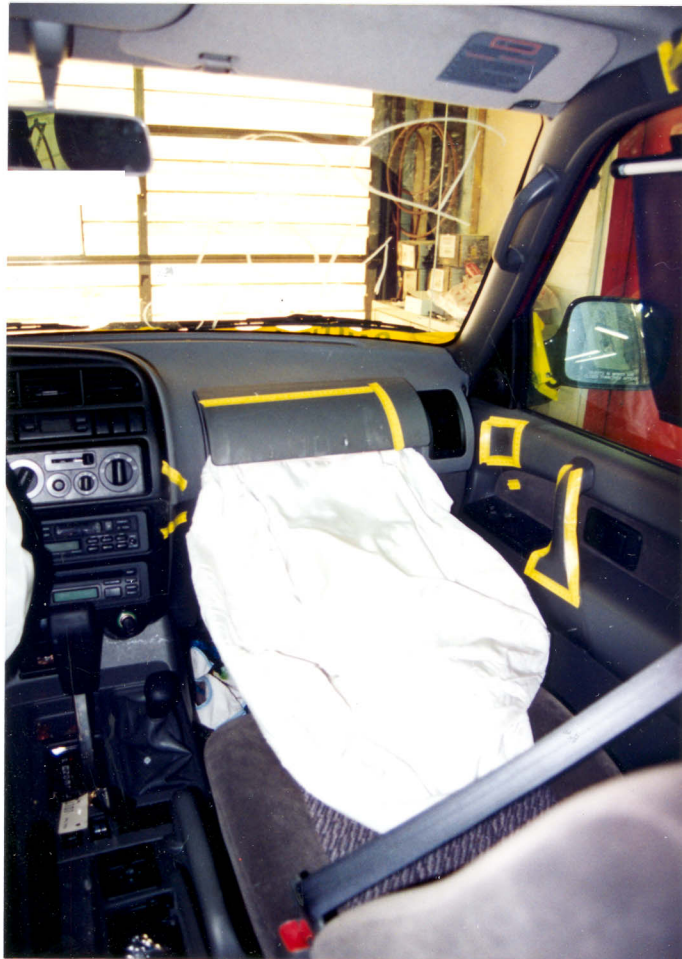
59. View of the right side instrument panel with the passenger side air bag extended from the module.

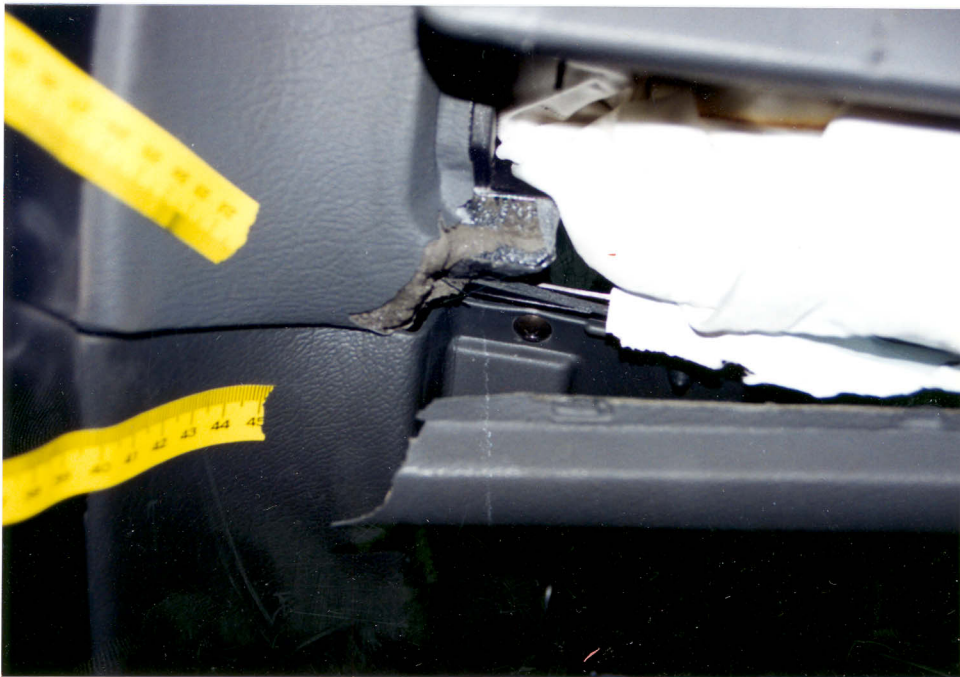
60. Close-up view of the broken portion of the right side instrument panel just below the passenger side air bag module.

A portion of the right instrument panel below the passenger side air bag module cover was separated at point located 20.3 cm (8.0") right of the vehicle centerline. This damage was the result of the expanding passenger side air bag during the SRS inflation sequence.

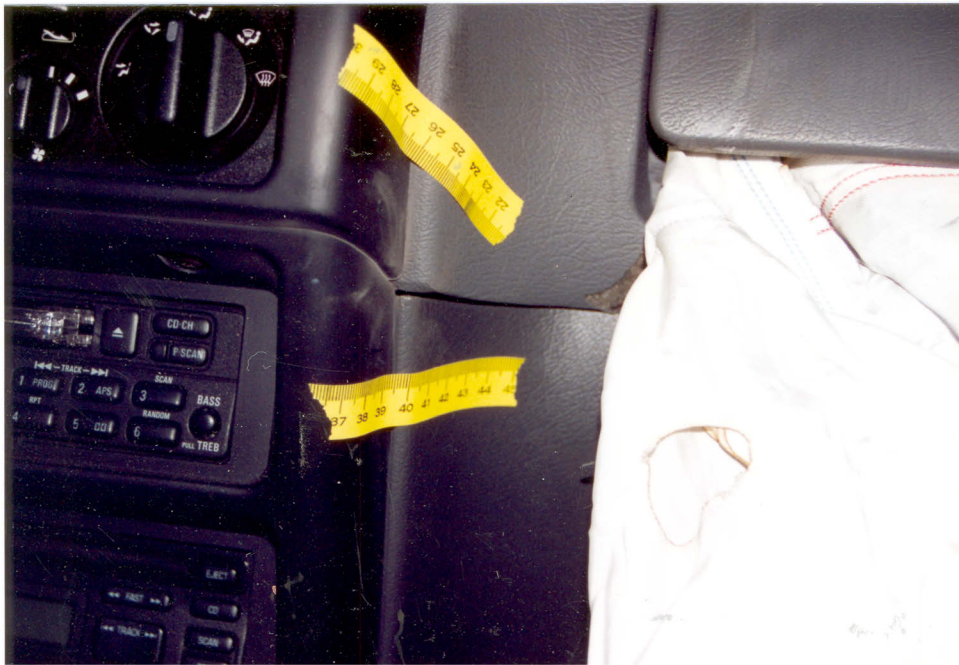
61. Close-up view of air bag generant residue located on the center instrument panel which was adjacent to the air bag vent port.

Two areas of passenger side air bag generant residue were noted on the right upper door surface and the right side of the center instrument panel accessory panel. The residue was gray in color and correlated with the location of the two passenger side air bag vent ports.

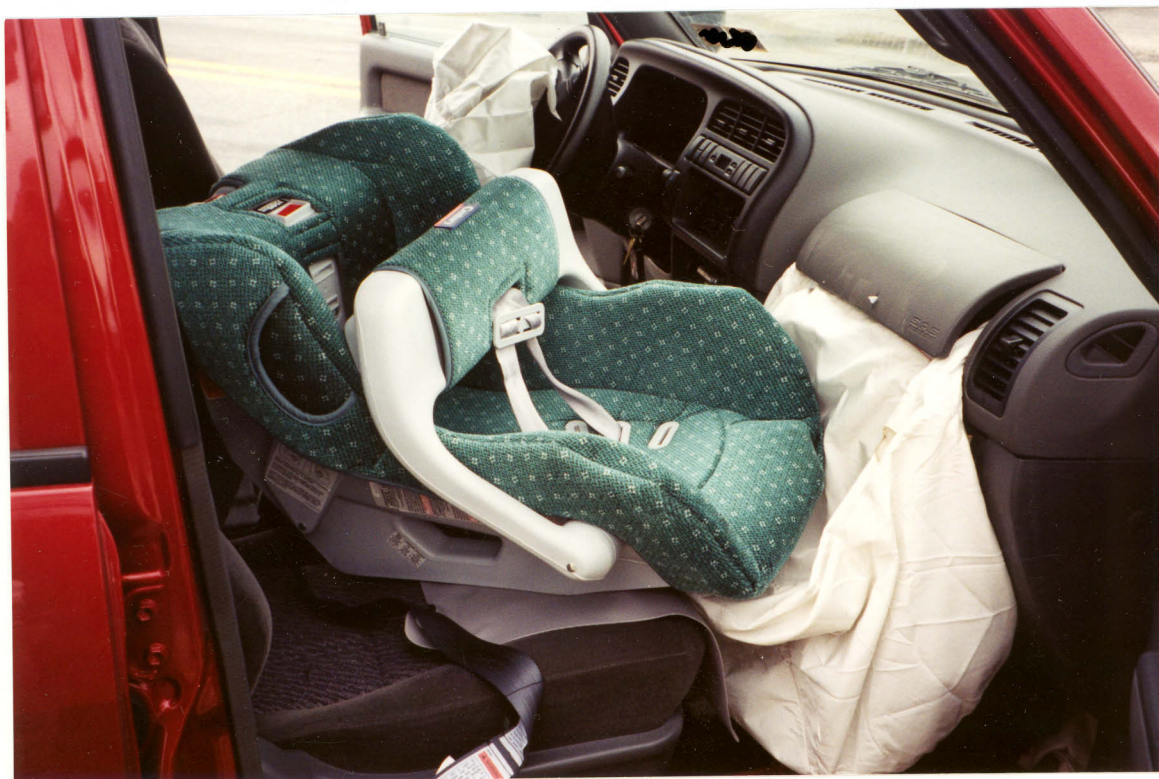
65. On-scene police photograph showing the position of the child safety seat upon arrival by the police.

On-scene photographs (refer to photographs #65-#67 on pages A-33, A-34) show the restraint belt latched and the safety seat laying on the seat cushion. It was reasoned that if the lap belt was used, then it had to be placed over the side surfaces of the safety seat on top of the green seat covering. Photographs #71 and #72 on page A-36 illustrate this technique and show the relative distance between the safety seat and the air bag module cover. In placing the seat in this position, care was taken to restrict the belt from rewinding into the retractor. Placement of the seat in this position appeared to place the seat at a distance that was inconsistent with the damage pattern noted on the rear surface of the seat and on the module cover (i.e., too far away). Additionally, there was no evidence of lap belt contact on the seat covering (e.g. fabric abrasion) or seat covering fibers embedded in the lap belt.

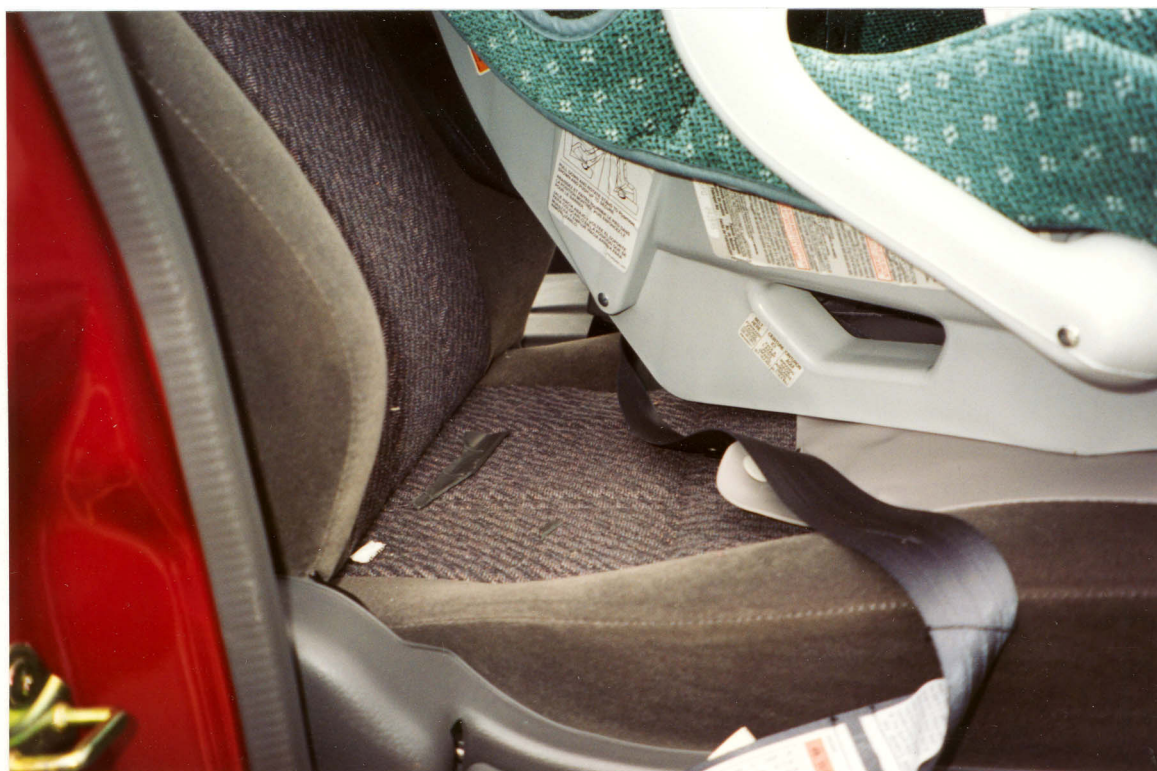
66. On-scene police photograph showing the lap portion of the manual three point lap and torso restraint belt.

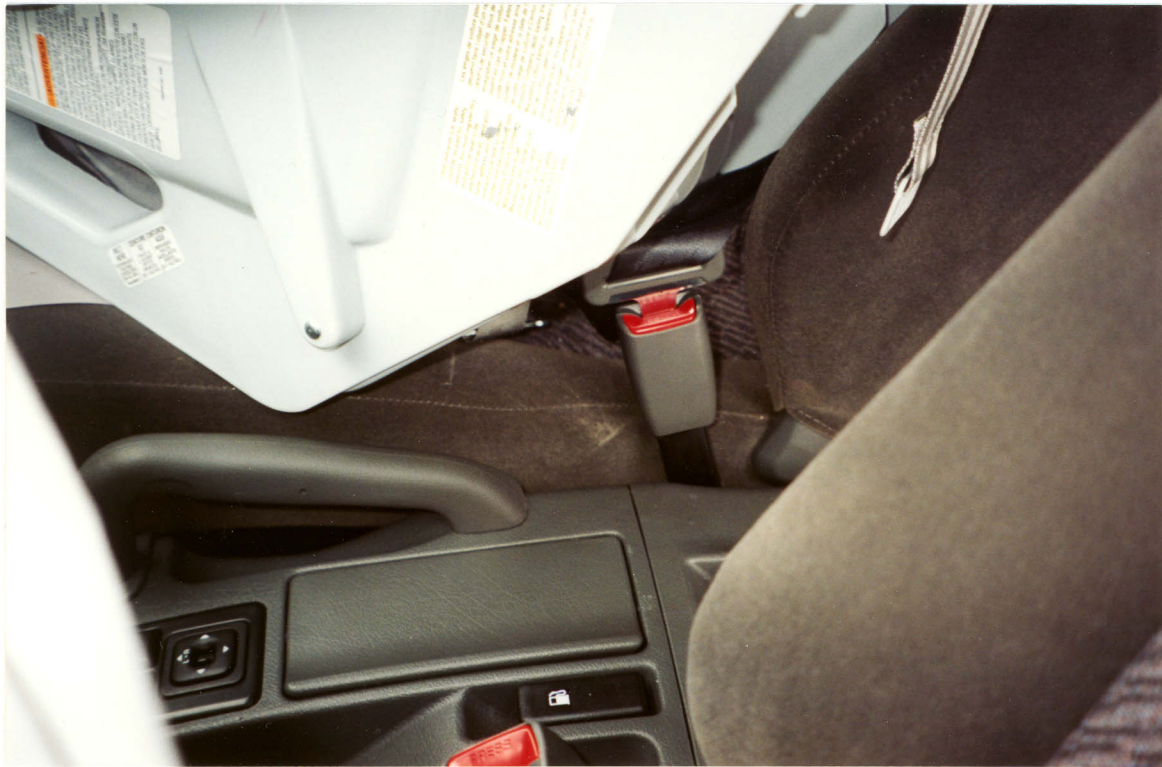
67. On-scene photograph showing the right front restraint belt latched upon arrival by the police department.

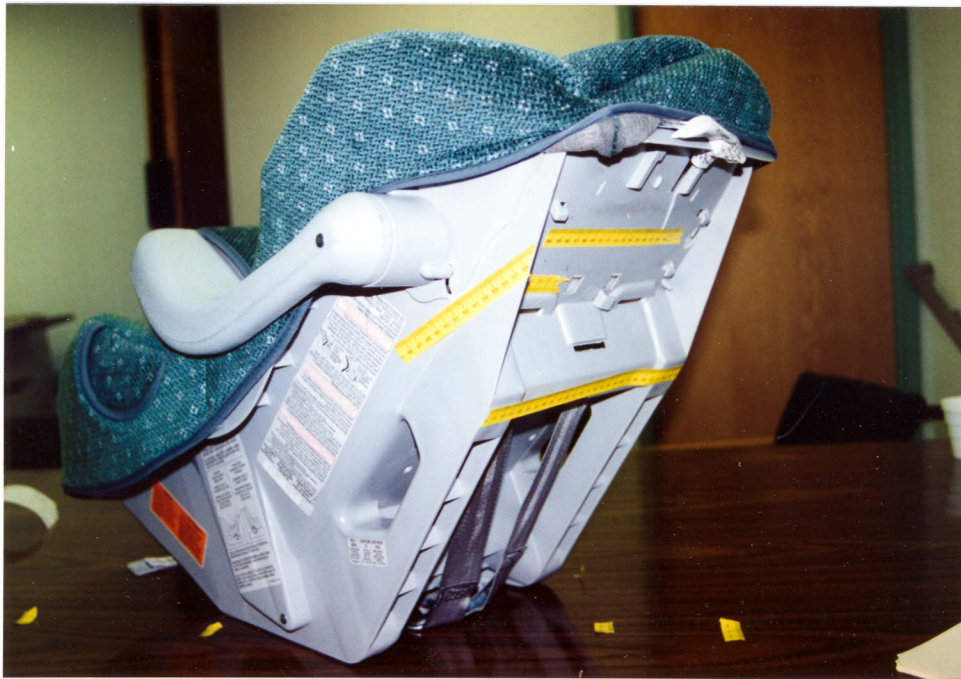
89. View showing damage to the child safety seat.

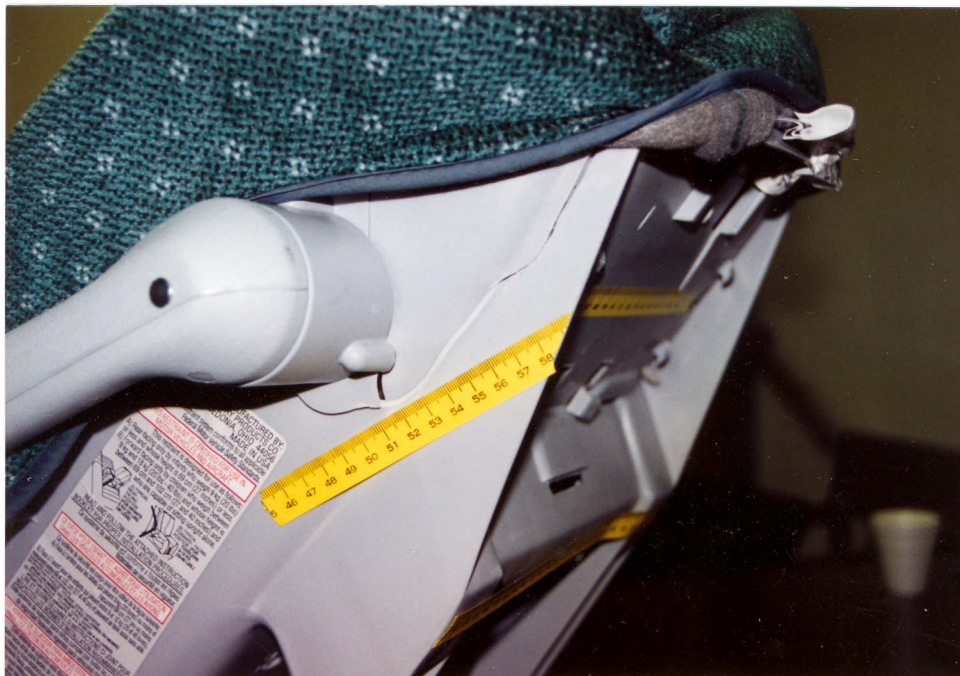
90. Close-up view of the fracture located adjacent to the shield support arm.

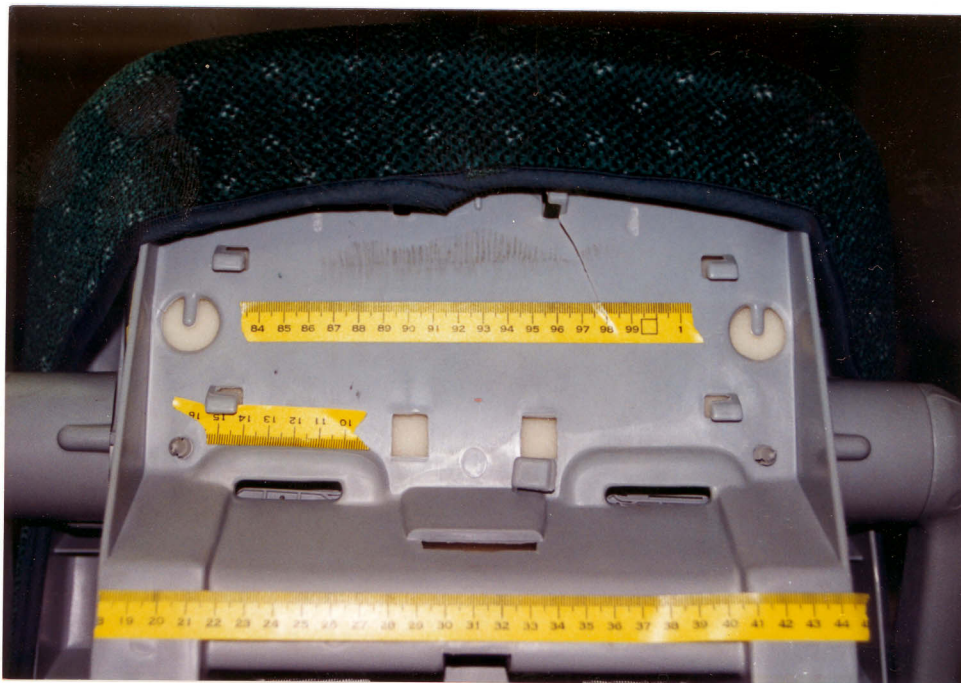
91. View of the passenger side air bag module cover and air bag contact evidence.

92. Close-up view of the contact evidence on the upper portion of the safety seat back rest from the passenger side air bag module cover.

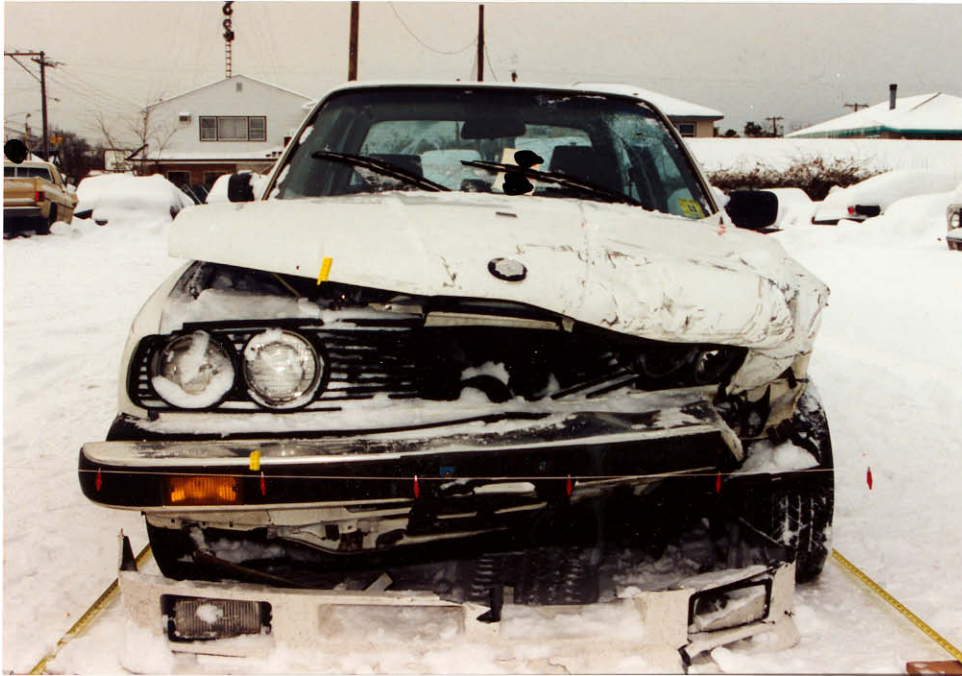
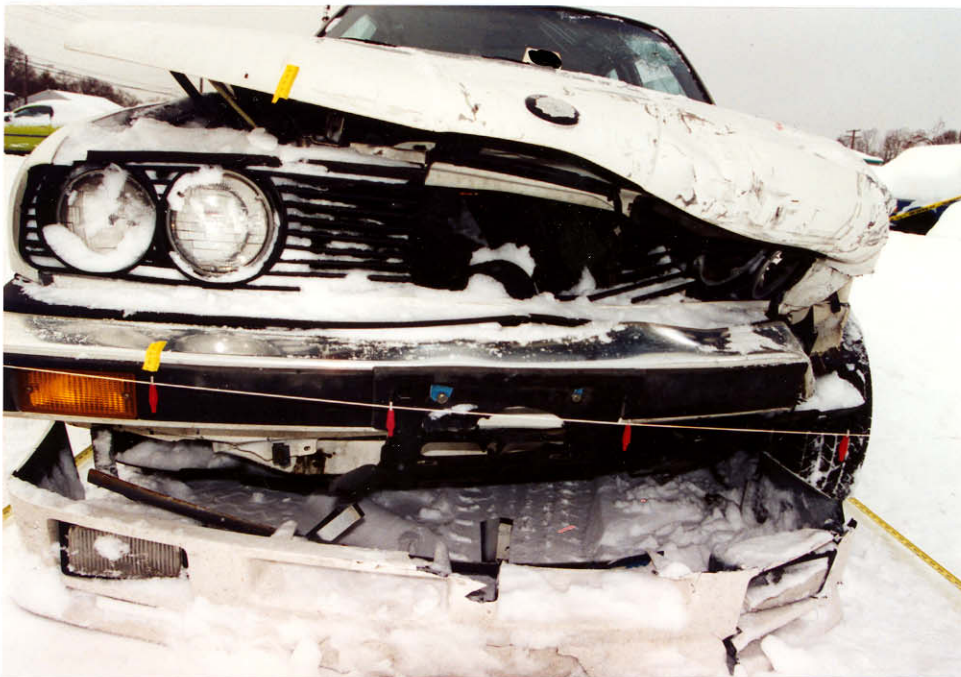
105, 106. Frontal views of the 1986 BMW 325 ES (Vehicle #2) showing impact damage.

Components damaged in the crash included the front bumper, the left headlight set, the hood, the lower valence panel, the grille area, the left fender, and the windshield.

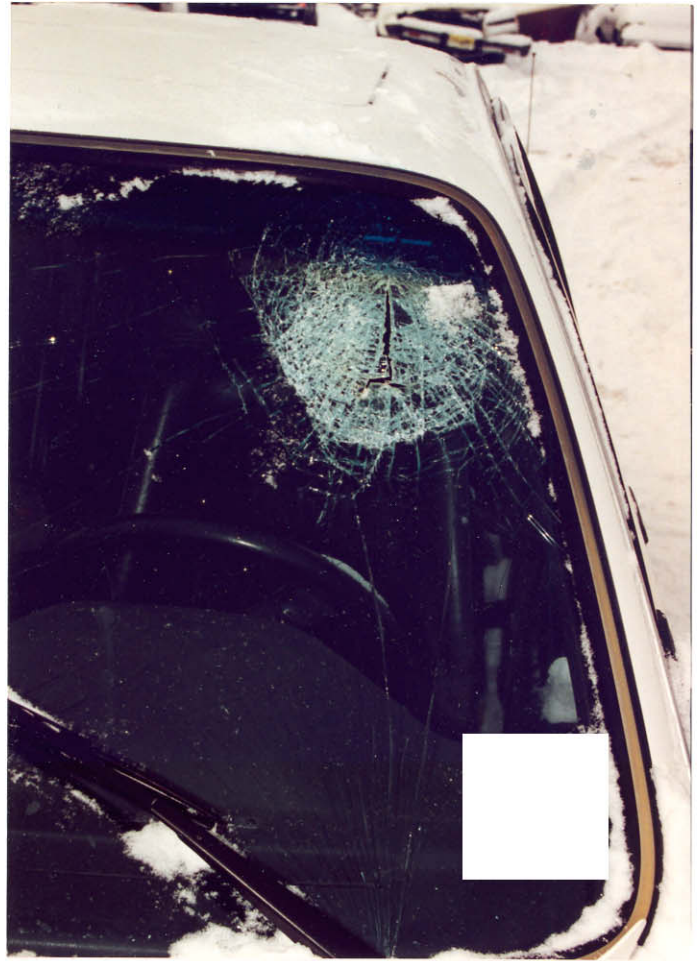
107. View showing contact evidence on the windshield by the unrestrained driver.

108. Lateral view from the right side illustrating longitudinal crush.

The interior of Vehicle #2 exhibited damage from contact by the driver's forehead. The windshield had a typical spider web contact pattern which was located 45.7 cm (18.0") left of the vehicle centerline. A 12.7 cm (5.0") slit in the glazing continued below this area. The driver sustained a laceration of the forehead which was attributed to this contact.

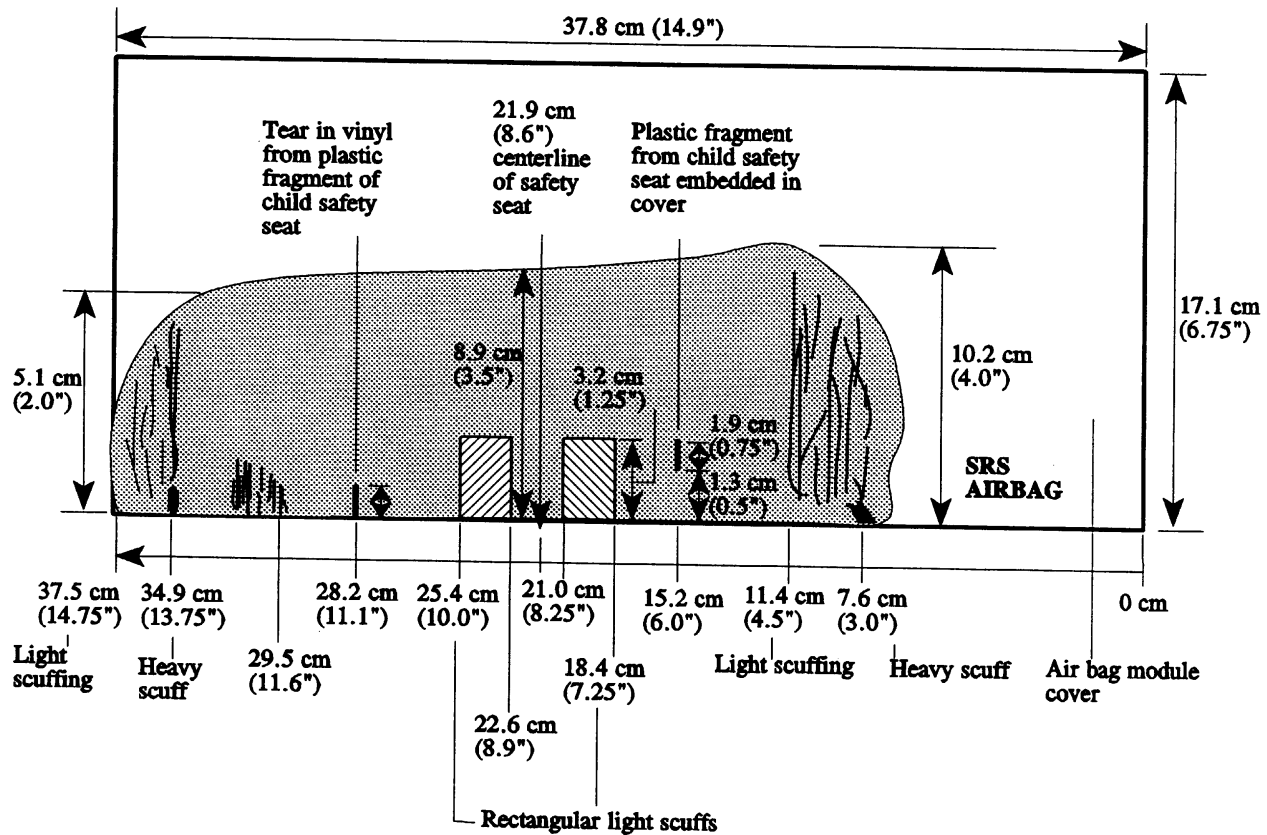
Contact Evidence On Surface Of Passenger Side Air Bag Cover

Imprint of the upper rear surface of the child safety seat is noted by the outline shown in the above sketch. There were two punctures of the air bag module cover which correlated with the two plastic tabs located 4.4 cm (1.75") below the top of the child safety seat and 6.4 cm (2.5") from the centerline of the seat. The right edge of the safety seat was located 34.9 cm (13.75") from the right edge of edge of the cover.
